Software Upgrade of Polycom[®] RealPresence Trio[™] 8800 SKUs (-018) for Microsoft Lync

Engineering Advisory 111066

This engineering advisory explains an issue upgrading software on Polycom[®] RealPresence Trio[™] 8800 phones registering with Microsoft Lync Server.

This engineering advisory applies to RealPresence Trio 8800 phones with part number 2201-65290-018 running Polycom UC Software 5.4.0 Rev AA (5.4.0.12541) or earlier.

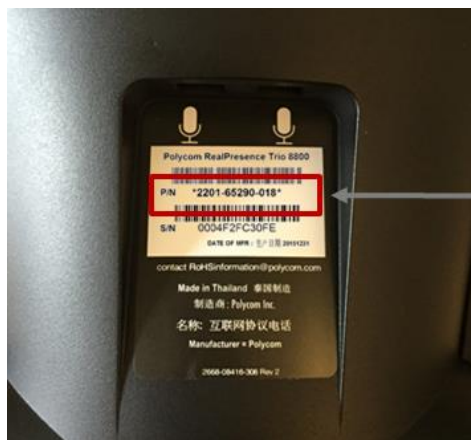
Part Number

The phone's part number is located on the back of the phone, on the label with the bar codes, as shown next.
